PASSAIC RIVER BASIN
STONY BROOK TRIBUTARY
MORRIS COUNTY
NEW JERSEY

DIXONS POND DAM^E

NJ 00175

PHASE 1 INSPECTION REPORT
NATIONAL DAM SAFETY PROGRAM

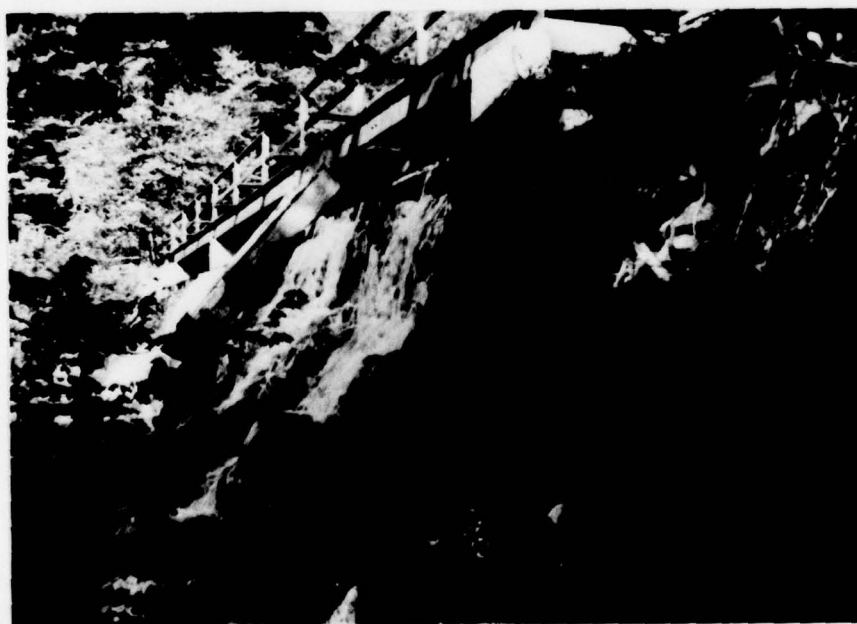
SPILLWAY LOOKING SOUTHWEST TOWARD RIGHT
ABUTMENT, WITH LOW LEVEL OUTLET PIPE

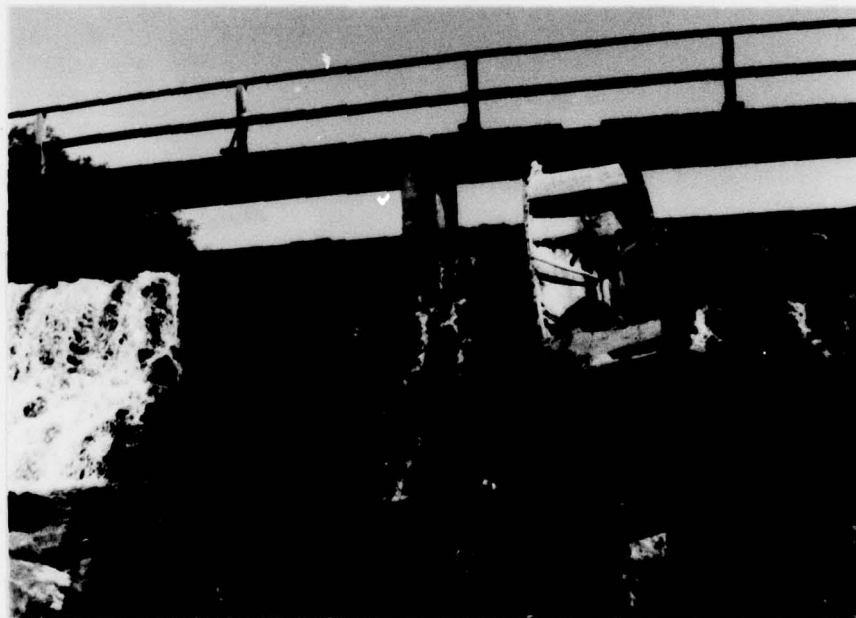
c. Visual Observations. No visual evidence of damage to the structure caused by overtopping was found. Debris, such as the derelict boat, may partially obstruct the spillway opening and cause serious reduction in the capacity during a flood occurrence. At the time of inspection, less than 1-inch of water was passing over the spillway crest. The low level outlet was leaking.

SPILLWAY AND SERVICE BRIDGE WITH
DERELICT BOAT, LOOKING UPSTREAM

d. Within three months from the date of approval of this report the owner should remove debris from the crest of the dam and the downstream channel area.

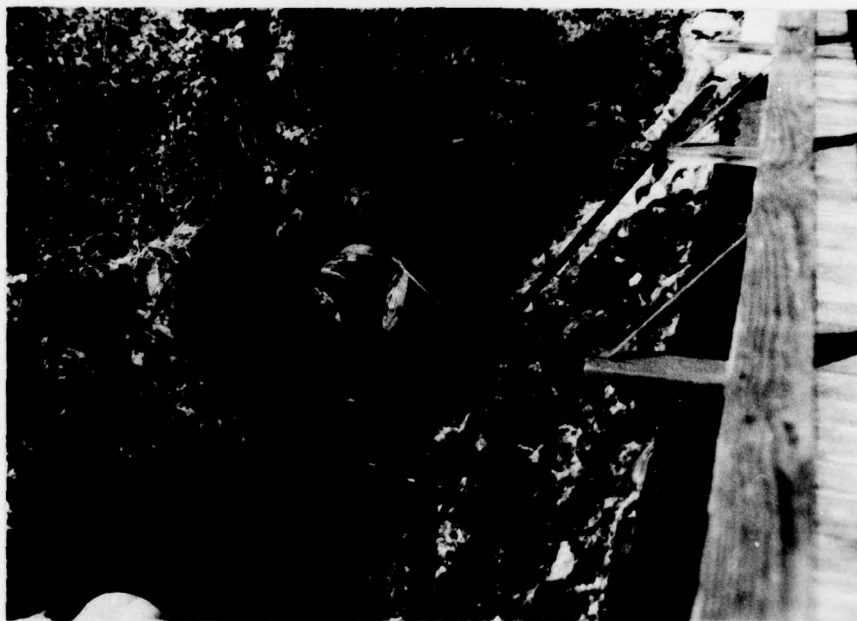
VIEW DOWN ON SPILLWAY FACE FROM SERVICE
BRIDGE TOWARD RIGHT ABUTMENT. NOTE DEBRIS.

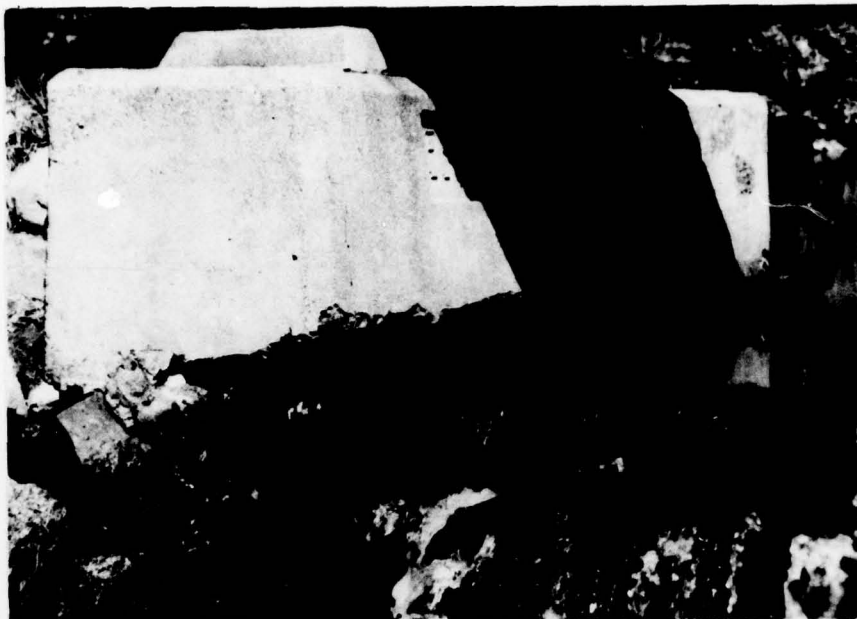
RIGHT ABUTMENT OF SERVICE BRIDGE
